# Confidential Inspection Report

August 12, 2010

RE: 1234 Pleasant Dr., Indianapolis, IN

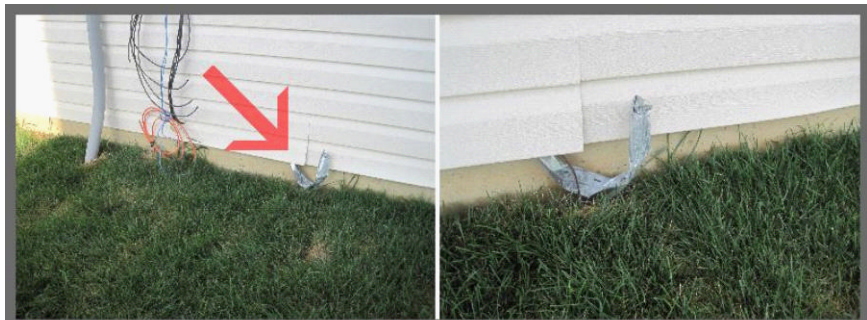
Walls are constructed with: Vinyl lap siding, Partial brick front. Damaged metal starter strip at bottom of west wall vinyl siding needs replaced.

**Replace metal starter strip**

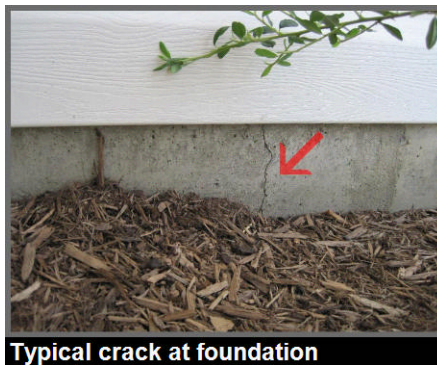
Poured in place concrete slab, Satisfactory - The exposed portions of the perimeter foundation walls appear to be adequate. Typical shrinkage/settlement cracks noted.

**Typical crack at foundation**

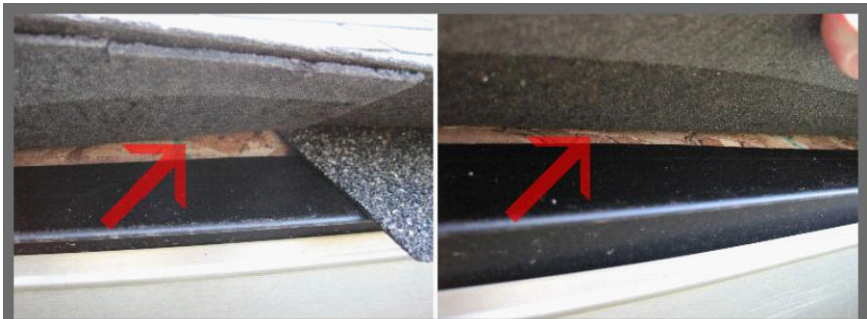
Standard three-tab composition shingles, One layer. Improper installation is found - No roofing underlayment felts were visible under shingles at first row of shingles. Underlayment felts are recommended by most manufacturers to be installed on top of roof decking before shingles are installed.

No underlayment felts visible

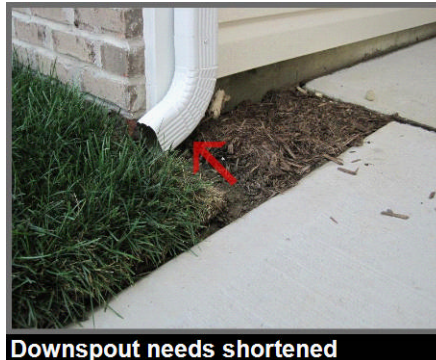
Standard gutters installed, Install missing splash blocks at downspouts. Downspout at front porch needs shortened before splash block is installed.

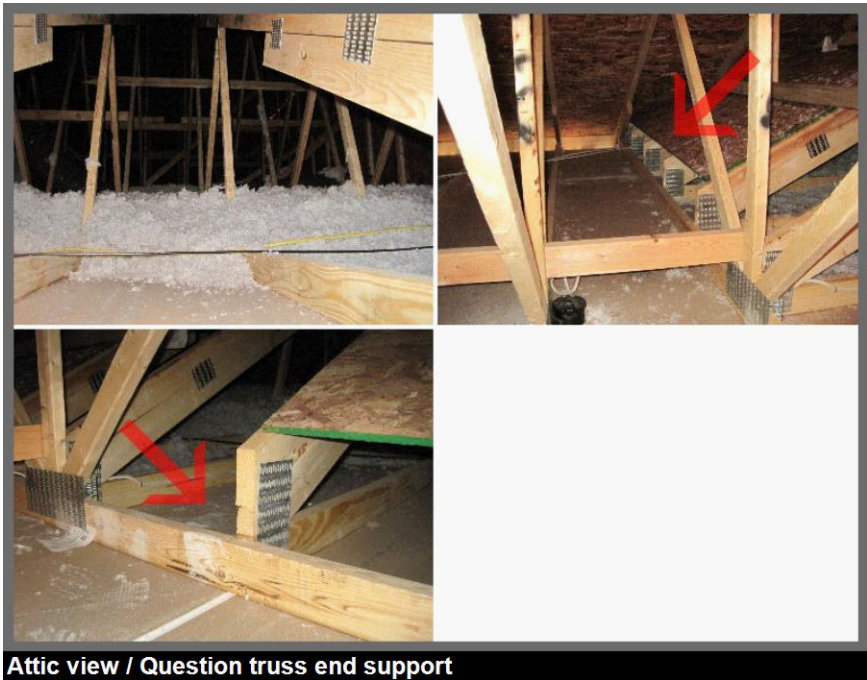
A truss system is installed in the attic cavity that is used to support the roof decking and transmit the roof load to the exterior walls. The truss or rafter spacing is 24 inches on center. The roof decking material is oriented strand board sheathing. The builder installed ply clips when installing the sheathing to prevent the sheathing from sagging at the joints. Request builder verify structural adequacy of truss end support in attic - North/south trusses are supported by a single east/west truss located south of attic access opening.

Attic view / Question truss end support

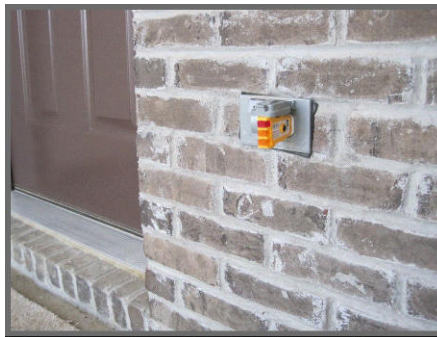
OK	MM	RR	
5.20 General:	..	..	⌋	Ground Fault Circuit Interrupter (GFCI) outlets are highly recommended for installation at exterior.
5.21 Exterior Walls:	..	..	⌋	Standard outlets installed - Ground Fault Circuit Interrupter (GFCI) outlets are recommended for installation at exterior locations (front and rear porches and west wall). West wall and rear porch outlets show no power when tested.

**Front porch outlet didn't trip when tested**

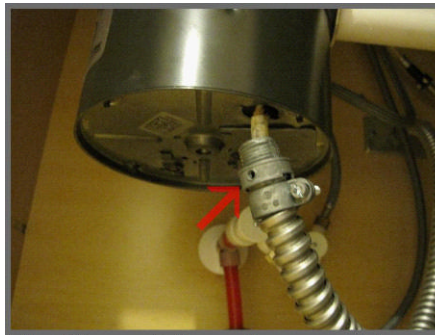
8.5 Condition:	..	..	p	Appears serviceable. Improper wiring - Flex conduit needs secured to bottom plate of disposal.
----------------	----	----	---	--

**Flexible conduit needs secured to disposal**

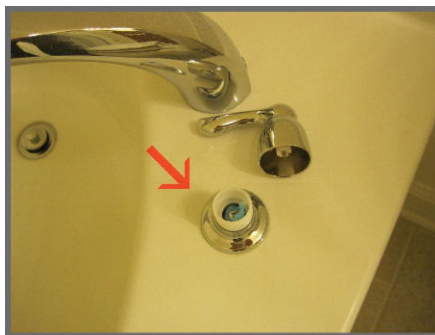
9.5 Hall Bath:	p	"	"	Appear serviceable.
9.6 Master Bath:	"	"	p	Tub faucet handle is broken and needs replaced.

Broken tub faucet handle

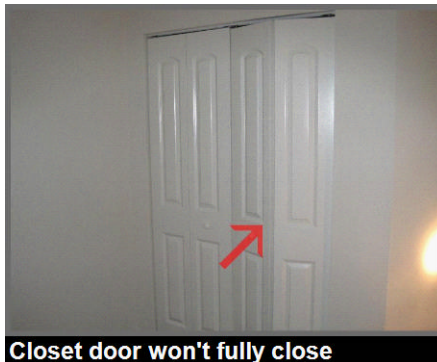
| 10.35 North Bedroom #2: | The closet doors or fixtures need some adjustment or repair. Bi-fold door would not fully close. |

Closet door won't fully close

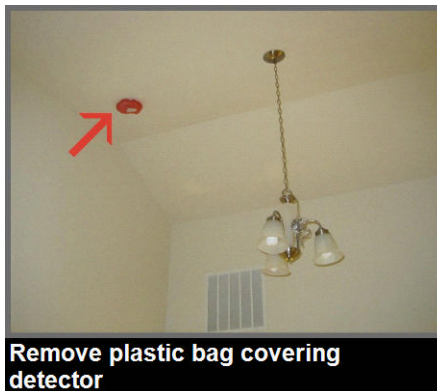
| 10.39 Living Room: | | Plastic bag covering smoke detector should be removed. |

Remove plastic bag covering detector
