# Confidential Inspection Report

August 12, 2010

RE: 1234 Pleasant Dr., Indianapolis, IN

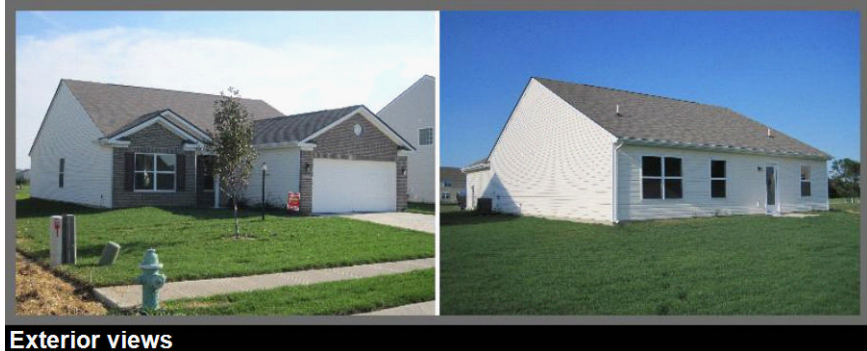
**Exterior views**

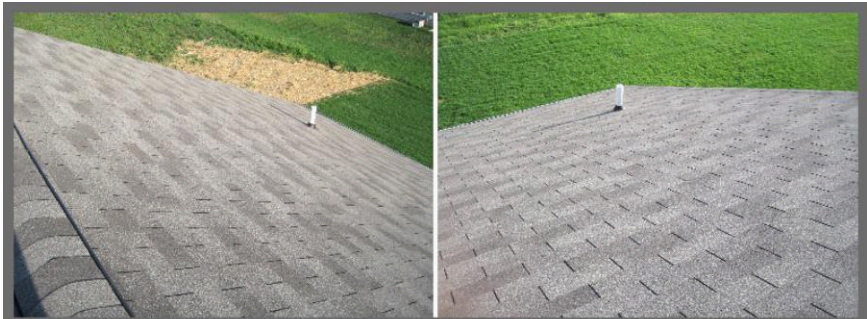
Standard three-tab composition shingles, One layer. Improper installation is found - No roofing underlayment felts were visible under shingles at first row of shingles. Underlayment felts are recommended by most manufacturers to be installed on top of roof decking before shingles are installed.

Roof views

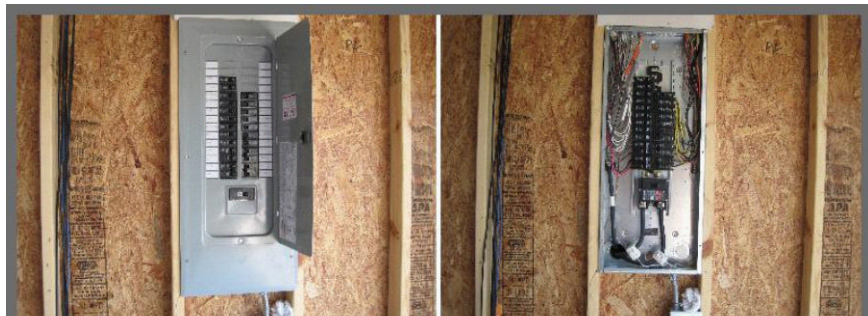
**Main electrical panel**

5.4 Main Panel Observations:	p	..	..	Circuit and wire sizing correct so far as visible, Grounding system is present.
5.5 120 Volt Circuits:	14.			
5.6 240 Volt Circuits:	5

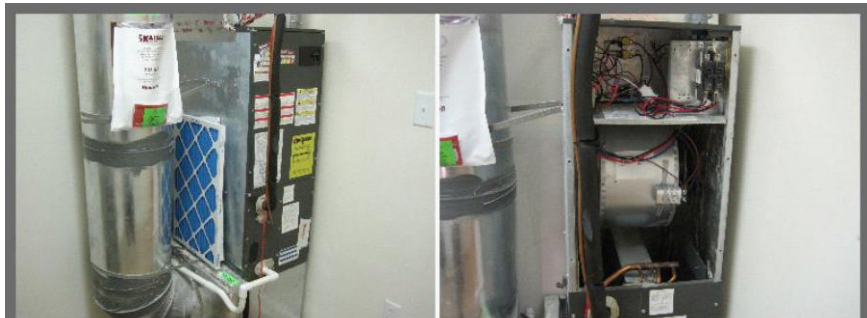
Forced air electric furnace. Manufacturer: Goodman, Model #ARUF182416BA, Serial #1005013342. Location: Laundry/Utility room.

**Electric furnace**

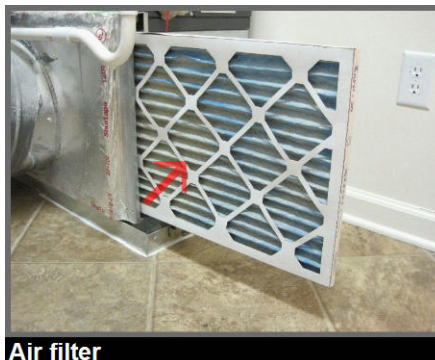
p	..	..	Size = 16"x25"x1"
---	----	----	-------------------

**Air filter**

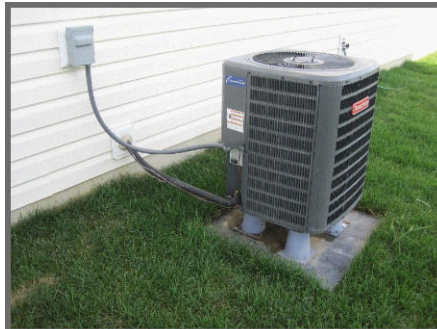
Central, Split system, Split system, Heat pump, Manufacturer: Goodman, Model #GSZ130241BA, Serial #1006713192.

Outside A/C unit

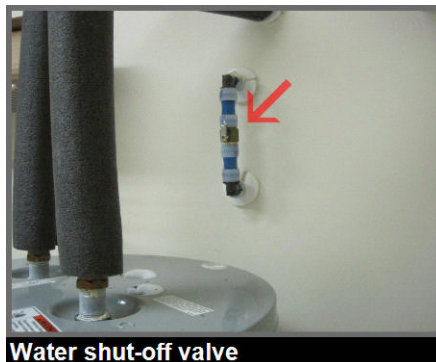
Water meter is located at the north side of the house. Main shutoff valve is located by water heater, Valve is operational.

**Water shut-off valve**

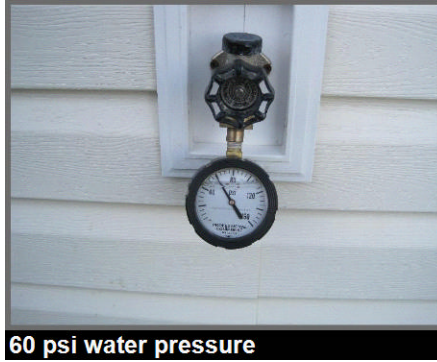
Water pressure was checked at an exterior hose faucet - Measured 60 psi. Water pressure from 40 to 80 pounds per square inch is considered within normal/acceptable range.

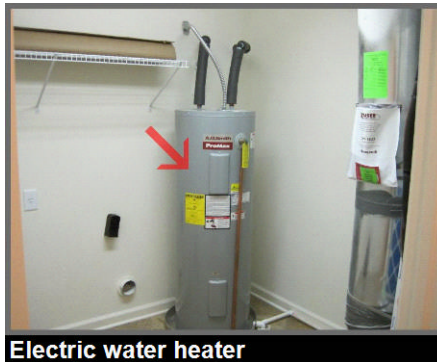
Manufacturer: A.O. Smith, Model #E62-50H-045DV, Serial #1021T448420. 50 gallons.
